Shipboard Exposure Testing of Aircraft Materials

Edwin S. Tankins*, J. Kozol & E. Lee

A study was performed comparing the corrosion resistance of various aluminum alloys in shipboard environments with an accelerated laboratory corrosion test environment. An Al-Li access panel for the F/A-18 was also tested. For comparison 7075 aluminum alloys were tested in the exfoliation susceptible T651 and the resistant T7351 temper.

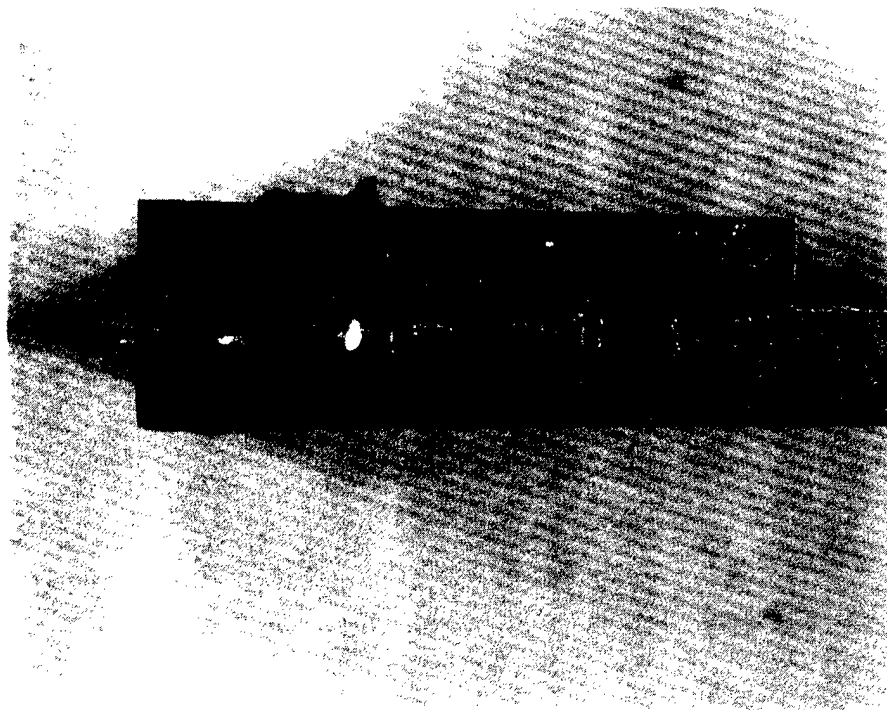
Fig. 5 - Side view of 7075 - 76 alloy showing extensive Ex_f liation.

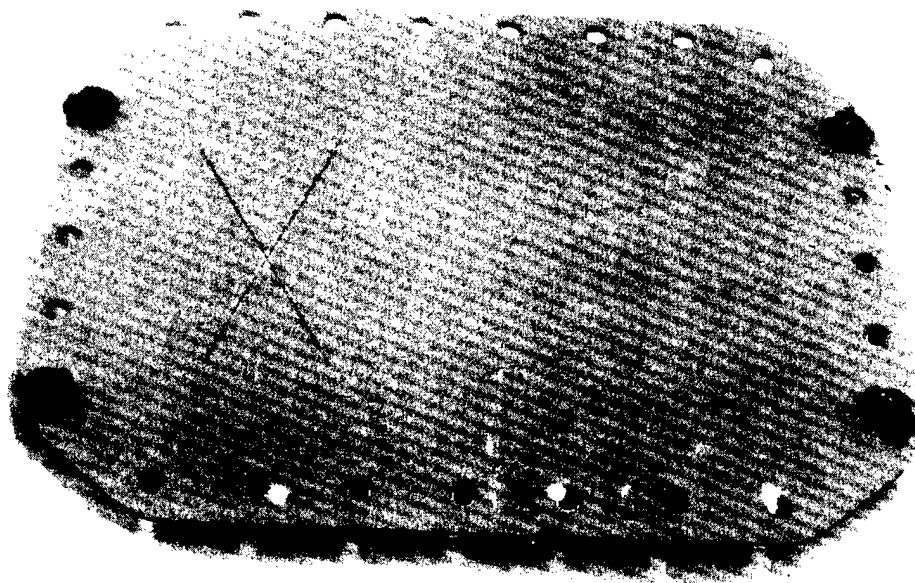
7075 T6
(a)

After 2 years at Key West, Florida, a small amount of incipient exfoliation appeared on the T/2 plane of the 7075-T6. Figure 6a compares access panels of 7075T6 and 209078 Al-Li alloy for the F/A-18. Figure 6b shows what looks like a slight blistering at the scribe mark. By comparison Fig 6b looks clean at the scribe marks. The behavior is basically comparable.

Fig. 6 - Access Panel from F/A - 18 with Scribe Marks.
